CASE STUDY

NE 28th/29th Alley

Between Killingsworth and Jarrett

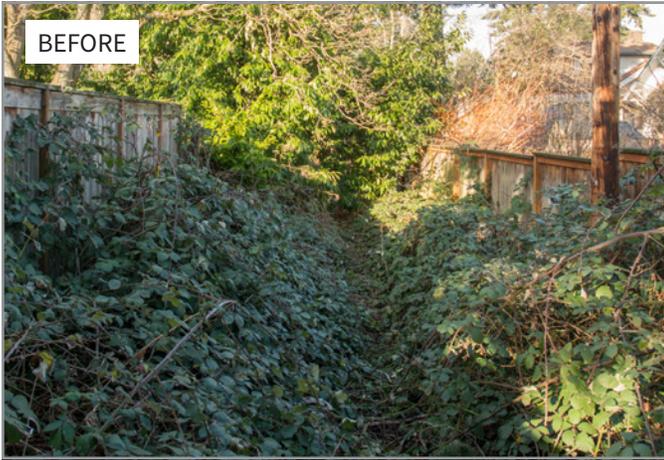
BEFORE

Prior to the start of the project, the entire unpaved portion of the alley was overgrown and passable only through a narrow footpath.

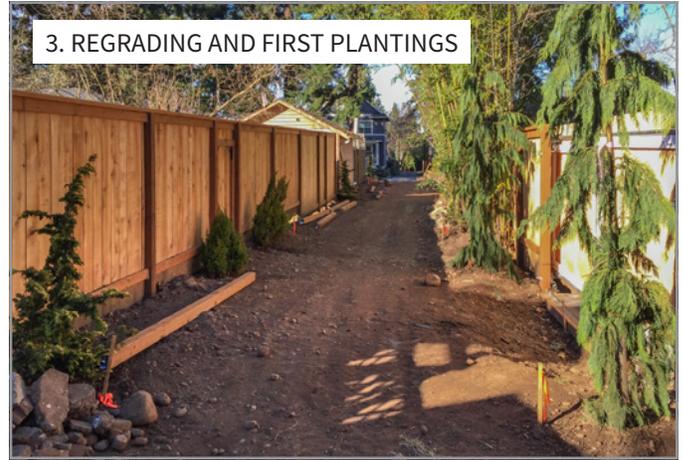
3. REGRADING AND FIRST PLANTINGS

The northern portion of the alley after removing extra topsoil with a backhoe and planting donated plants.

Step 3: Regrading and First Plantings

The plan was to regrade the surface, put down a barrier to prevent vegetation from returning, and then add compressed gravel to create a central path. Narrow planting strips were created in front of each property for residents to use. At the meeting they realized they had many resources available to them and many were willing to chip in money to pay for the materials they couldn't get donated.

For a portion of the alley, they were able to arrange a backhoe and source plants for free, for another portion, a Bobcat excavator was rented for a day to move soil. Neighbors split the costs for the drop boxes needed to remove the soil, the fabric barrier to prevent the vegetation from returning, and the gravel that they would cover the surface with.

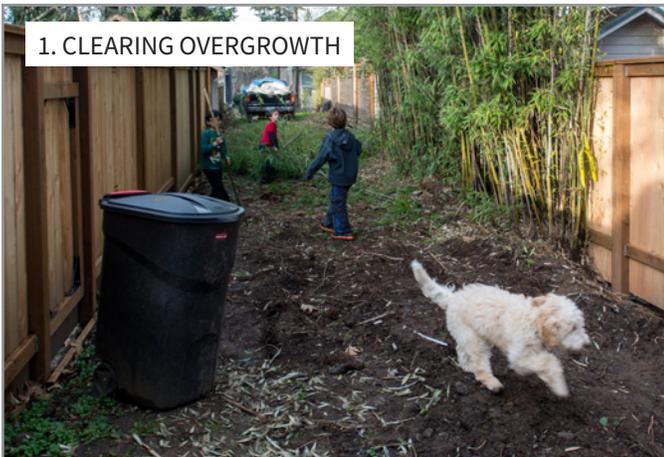
1. CLEARING OVERGROWTH

The residents cleared out the alley by chopping down blackberries and pruning back trees. They used a neighbor's truck to haul away debris.

Step 1: Clearing Overgrowth

The arrival of a new neighbor with a strong desire to access his garage from the alley, led the residents at the northern end to organize and clear out the alley out again. Learning from the previous clean up, this time they decided to improve the surface to stop overgrowth from returning. Residents knocked down the vegetation and hauled it away one truckload at a time.

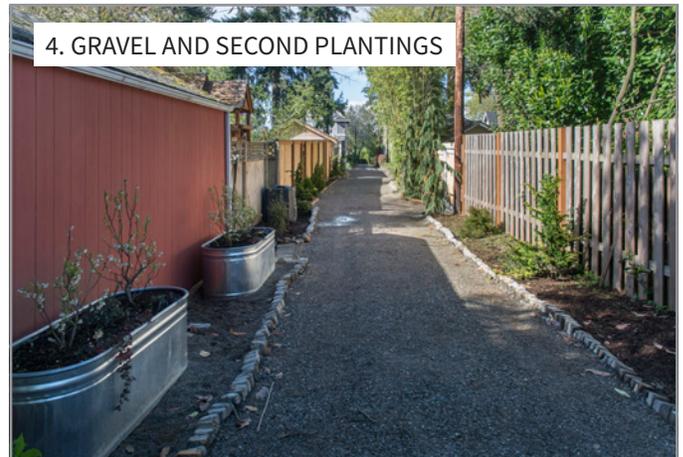
4. GRAVEL AND SECOND PLANTINGS

Recently residents have added plants and distinctive entrances from their properties into the alley. Next steps likely include lighting and murals.

Step 4: Gravel and a Second Round of Plantings

The residents moved quickly to stabilize the surface material once the soil was exposed. They chose 3/4 minus crushed rock that was compacted to create a tough surface for cars and bikes that still allows rainwater to drain into the soil. Many of the residents are adding their own unique landscaping to their alley "front door" such as brickwork, steps, pea gravel and planters.

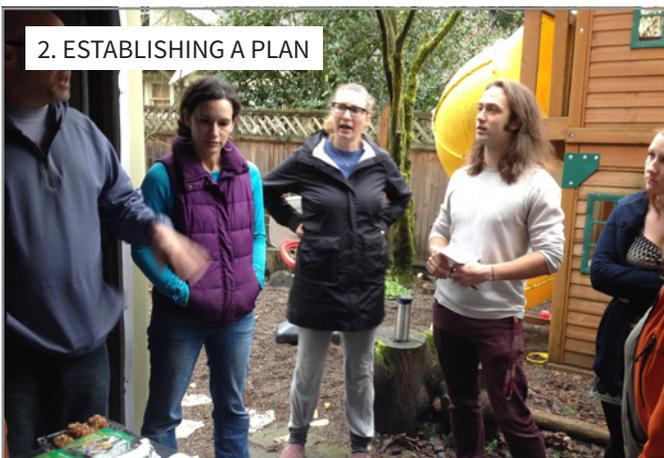
2. ESTABLISHING A PLAN

PSU students led a discussion about the residents' shared goals for the project. Residents found they had many skills and resources to contribute.
